Manhole Inspection Summary

Manhole # S07UU1012MH

Insp Date: **9/27/06 10:06 AM**

Location Address: **3000 W ROGERS AVE**

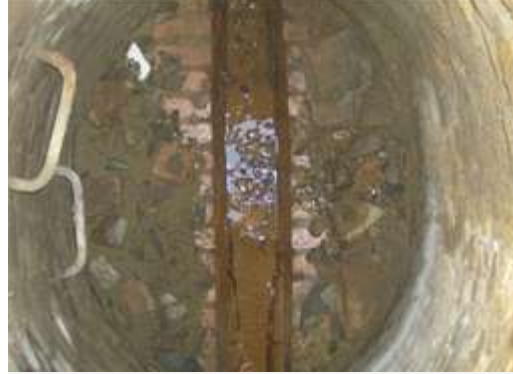
Top View

Corroded steps. Evidence of surcharge - Bench debris. Channel debris.

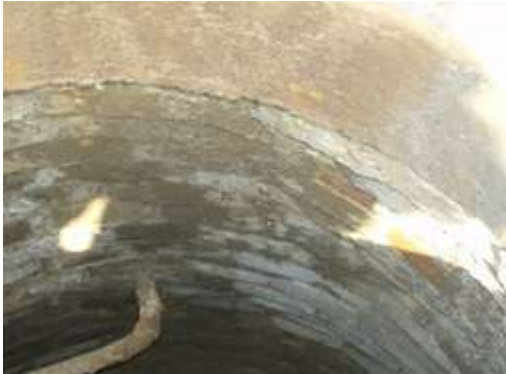
Defect

Frame leaks. Adjustment, Corbel, and Barrel infiltration - other side.

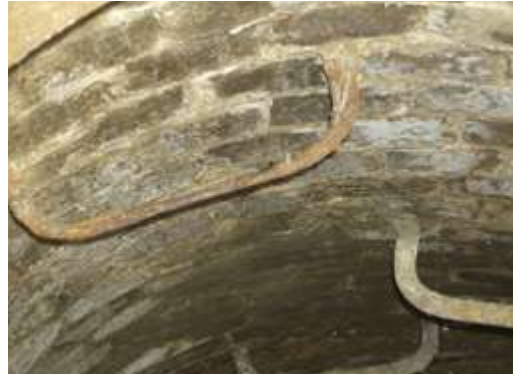
Defect

Adjustment, Corbel, and Barrel infiltration.

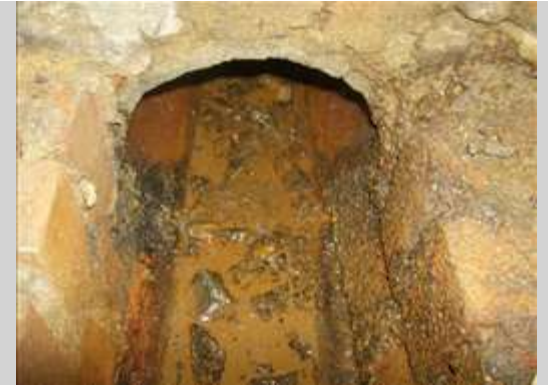
8 in. Circular Gravity Sewer Pipe Out @ 12 O'Clock

Deposits: ☐ None ☐ Mud ☐ Sludge ☒ **Debris** ☐ Grease

Silt Depth: **0** (in.) Deposits Extent: **Light**

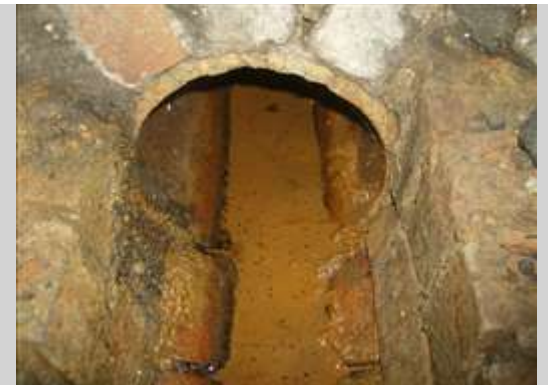
8 in. Circular Gravity Sewer Pipe In @ 6 O'Clock

Deposits: ☐ None ☐ Mud ☐ Sludge ☒ **Debris** ☐ Grease

Infiltration: **Evidence** Pipe Seal Cond: **Unknown**
